DEFECT INVESTIGATION OF CARTRIDGE
ILLUMINATING 1-1/2 INCH

M.A. Wilson and R. Bird

TECHNICAL NOTE

- M R L - T N - 5 0 1

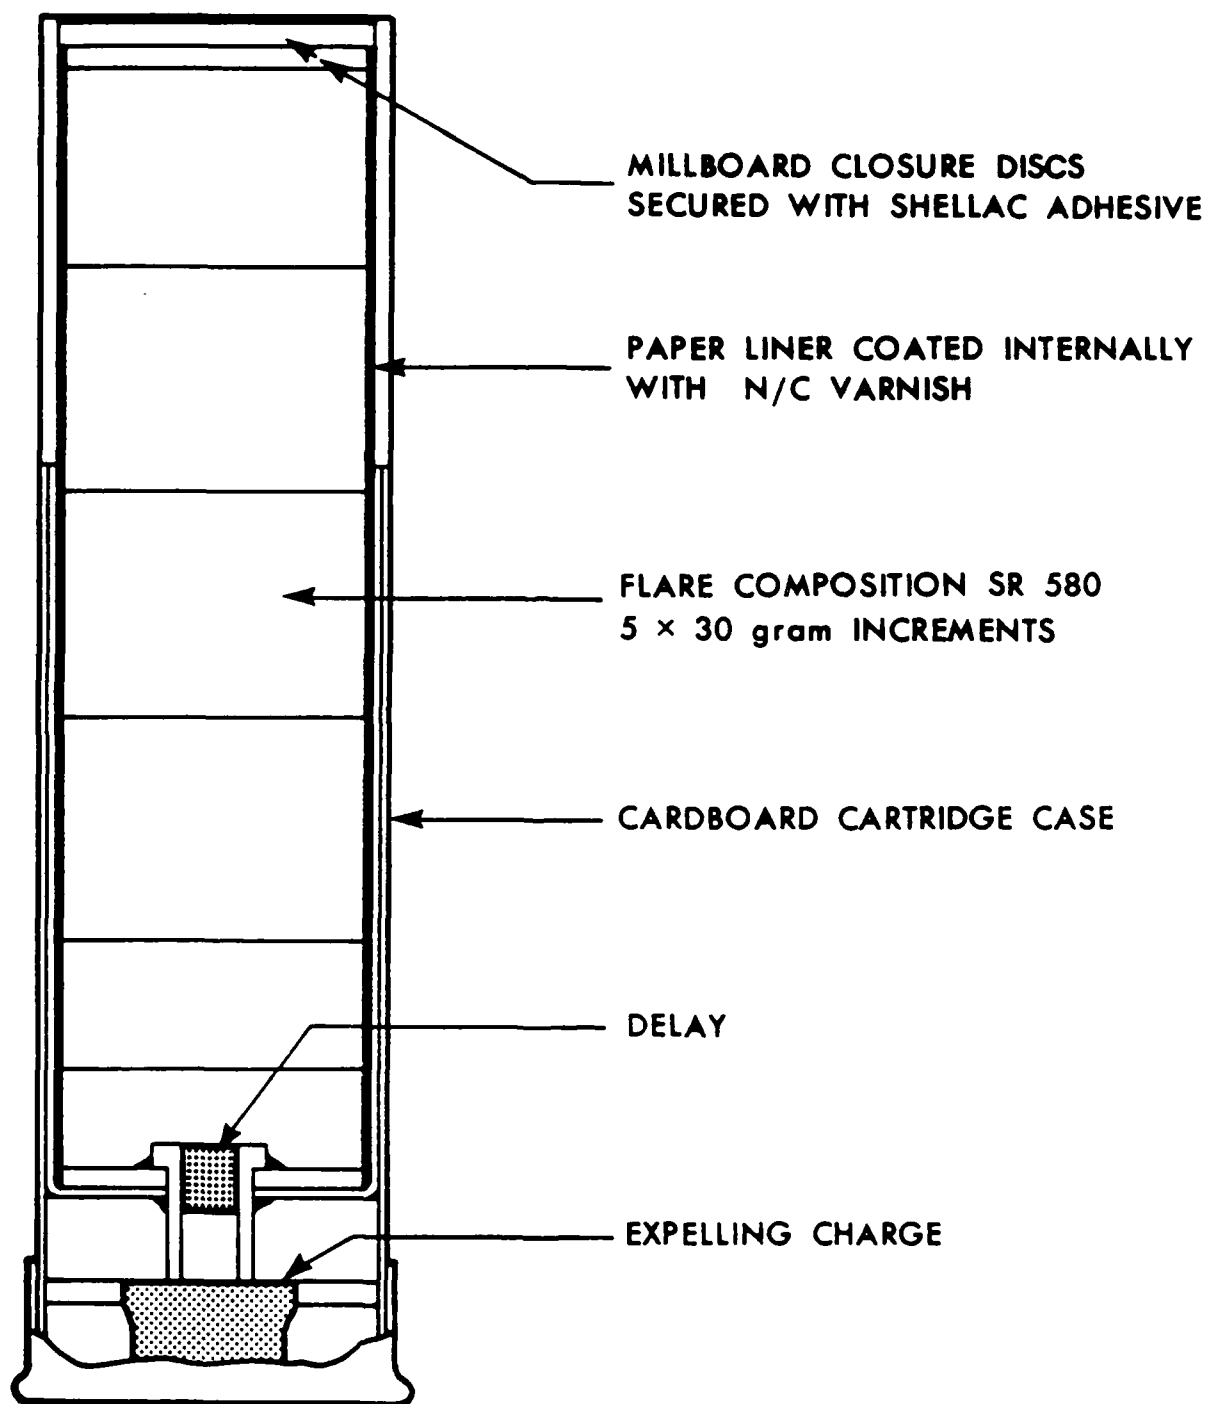
FIGURE 1 Cartridge Illuminating 1-1/2 inch J Mark 4T

The cartridge illuminating 1-1/2 inch J.Mark 4T (Fig. 1) contains pressed pellets of the flare composition SR 580 which was developed in 1937 at the Royal Armament Research and Development Establishment, Fort Halstead, UK. The composition contains 60 per cent magnesium powder, grade 4; 36 per cent sodium nitrate and 4 per cent acaroid resin. In order to reduce attack of the magnesium by moisture, the metal powder is coated with the resin from alcoholic solution, dried and then mixed with the oxidizer. The loose composition is pressed into a paper cylinder, the base of which is pre-coated with nitrocellulose varnish. The cartridge case is made of cardboard which is closed, after loading, with a millboard disc and shellac adhesive. The cartridges were manufactured at the Royal Ordnance Factory, Chorley, UK and have a recommended service life of five years from date of manufacture, subject to subsequent routine periodic inspection and proof. The cartridges are currently in service with the Royal Australian Navy and are normally stored in M19A1, and M2A1 boxes in lots of 10 and 20 respectively (Fig. 2). The free space in the boxes is packed with waxed paper to protect against vibration and rough handling. Both types of box incorporate a rubber gas seal in the lid.

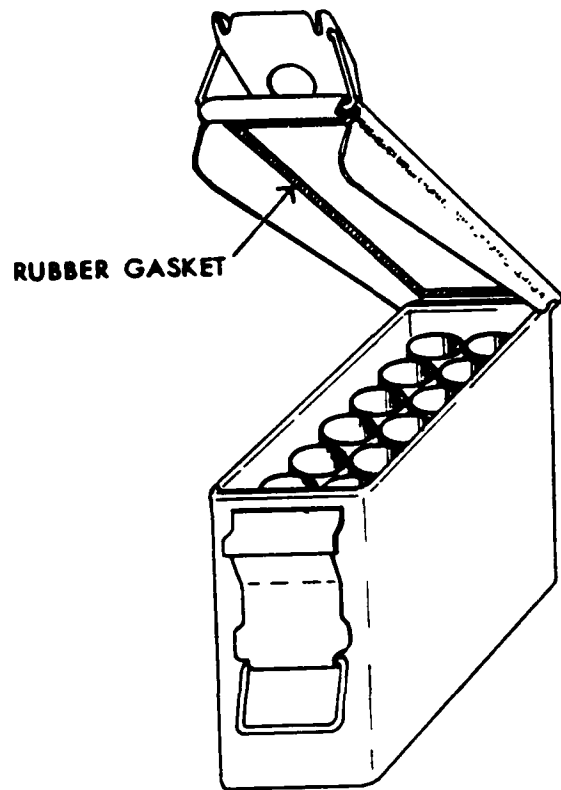
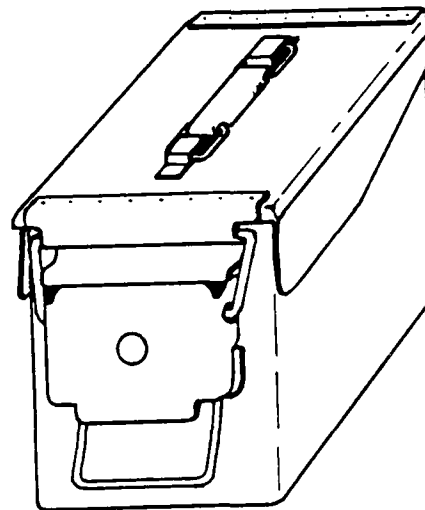
FIGURE 2

The containers, which had bulged due to internal pressure, were considered unsafe for transport; therefore three cartridges from one of the two suspect lots (CY6/76 and CY8/78) were repackaged into an ammunition box and forwarded to MRL by the Inspector of Naval Ordnance, Naval Armament Depot, Newington, NSW for examination. Discussions with NQAR, Newington revealed that both types of ammunition box had been opened within the last 2 years and now exhibited severe bulging of the sides and bottoms of the boxes. In order to determine indirectly the internal pressure, an M2A1 box was pressurized with air until deformation was similar to that of an unopened box held at INO, Sydney (Fig. 3). It was found that an internal pressure of approximately 100 kPa was required to bulge the sides of the box to the 13 mm noted by INO. Pressures in excess of this figure cause temporary venting past the seal in the lid which therefore acts as a limiting valve. A pressure of 100 kPa exerts a force on the lid of a M2A1 ammunition box of almost 4 kN. Upon opening, the lid will be propelled back against the hinge with considerable violence.
